Improving Public Transit Accessibility for Blind Riders by Crowdsourcing Bus Stop Landmark Locations with Google Street View: An Extended Analysis

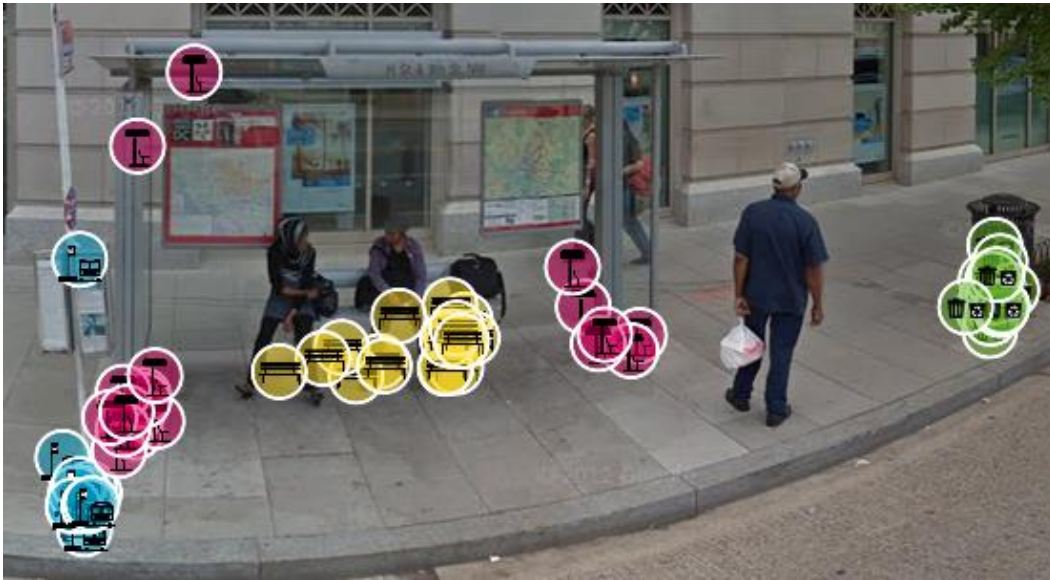
Figure 1: We built a system that allowed crowdworkers to collect detailed information about bus stops using Google Street View (GSV) to improve accessibility. Crowdworkers were asked to label the landmarks in a GSV image. The image above shows actual labels from crowdworkers (Study 3). From left to right: blue circular icon=bus stop sign, magenta=bus stop shelter, yellow=bench, green=trash/recycling can.

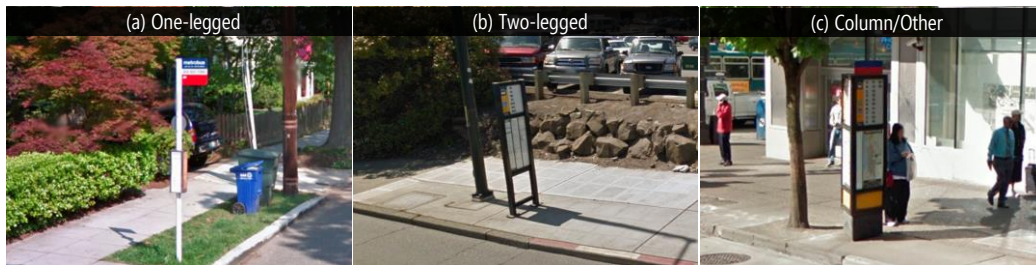
Figure 2: Three different bus stop sign designs: (a) one-legged, (b) two-legged, and (c) column/other. Some interviewees mentioned that knowing the shape of a bus stop sign a priori is helpful for locating a stop. These examples are pulled from our Study 2 and 3 areas in Washington DC (left) and Seattle (a and b).

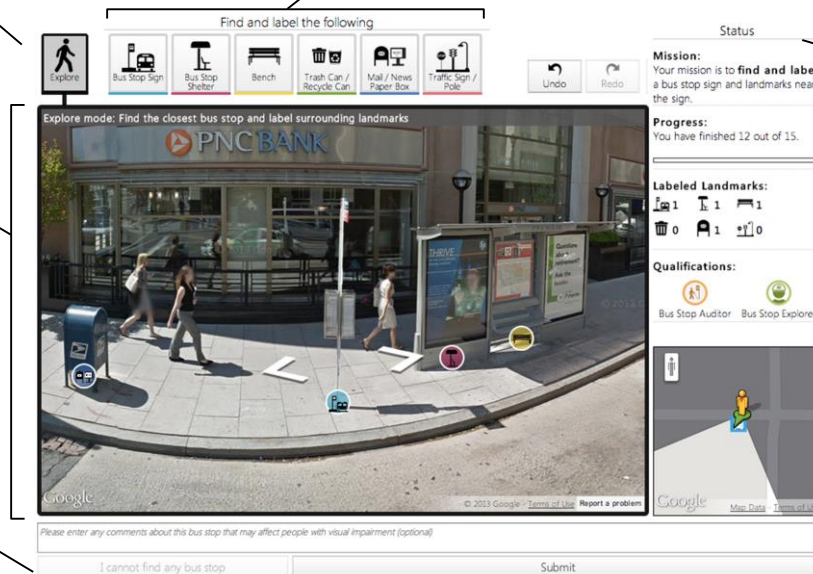
The **Status side panel** provides details on the user's progress and their qualification badges (which they earn in our interactive tutorials).

The user's location and view direction are represented in this **top-down 2D map view**. The bus stop icon (in blue) is drawn based on location data from Google.

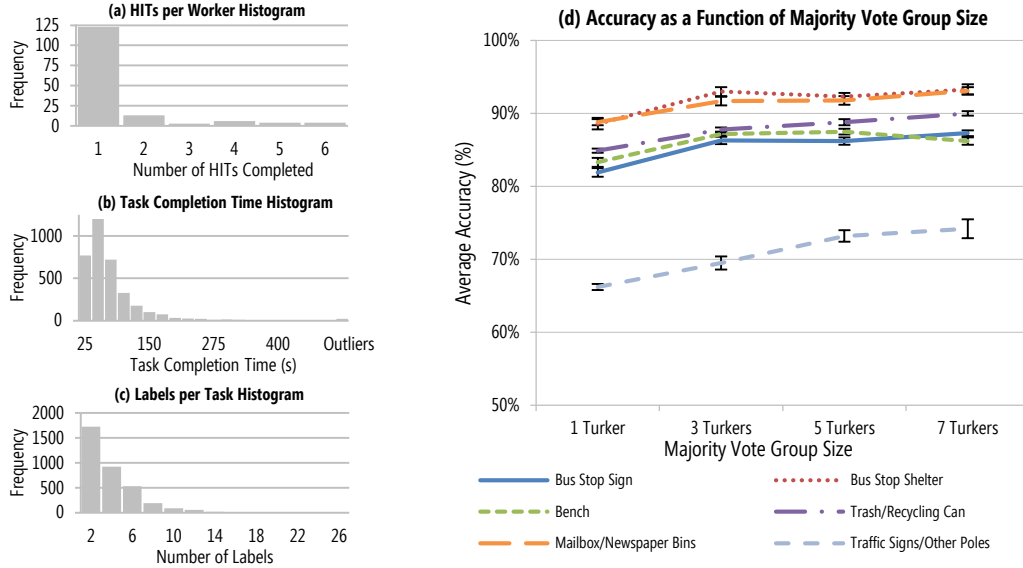
Figure 7: (a) A histogram of the number of HITs completed per worker. The long-tail distribution shows that most workers (123/153) performed a single HIT and left. (b) A histogram of task completion time. Most tasks (93%) were completed within 150 seconds. The rightmost bin includes outliers: 23 tasks with completion time >500s (max 7517s). (c) A histogram of label counts per task. Most turkers submitted under 6 labels, (d) Overall accuracy as a function of majority vote group size. Each graph point is based on multiple permutations of the majority vote group size across all 150 bus stop locations. Standard error bars are in black. Note: the y-axis does not start at 0% (range: 50-100%).

Overall, we found that accuracy does indeed increase with majority vote group size from 82.5% to 85.8% with 3 turkers and 87.3% with 7 turkers. These gains, in general, diminish in magnitude as majority vote group size grows (Figure 7d). However, for the hardest landmark label type (*Traffic Signs / Other Poles*), we see a continued steady increase as the majority vote size grows—perhaps indicating the wisdom in the crowds for more challenging landmark types.

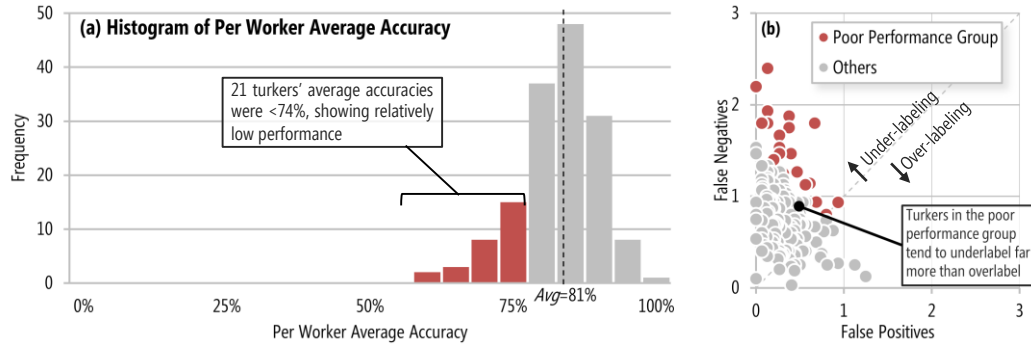
Figure 8: (a) A histogram of per turker average accuracies of 153 turkers (bin size = 5%). (b) A scatter plot of the average false positive *vs.* false negative errors for each of the 153 turkers. Each point indicates a turker; the 21 “poorly performing” turkers are highlighted in red.

To better understand the behavior of this poor performing group, we examined their false positive and false negative error behaviors and compared them to the “other” group. A false positive indicates that a turker provided a label for a landmark that does not actually exist in the scene (*i.e.*, over-labeling). Conversely, a false negative means that the turker missed labeling a landmark that actually existed at the bus stop (*i.e.*, under-labeling). Overall, the average false positive and false negative rate in the poor performing group was 0.4 ($SD=0.3$) and 1.5 ($SD=0.4$) respectively compared with 0.3 ($SD=0.2$) and 0.7 ($SD=0.3$) for the other group. While false negative errors were more common than false positives for both groups, the poor performers had a higher number of both (Figure 8b). More work is needed to determine why false negatives are more prevalent. For example, it would be interesting to investigate whether false negatives are due to a misunderstanding of the task, problems with occlusion, or simply worker apathy.

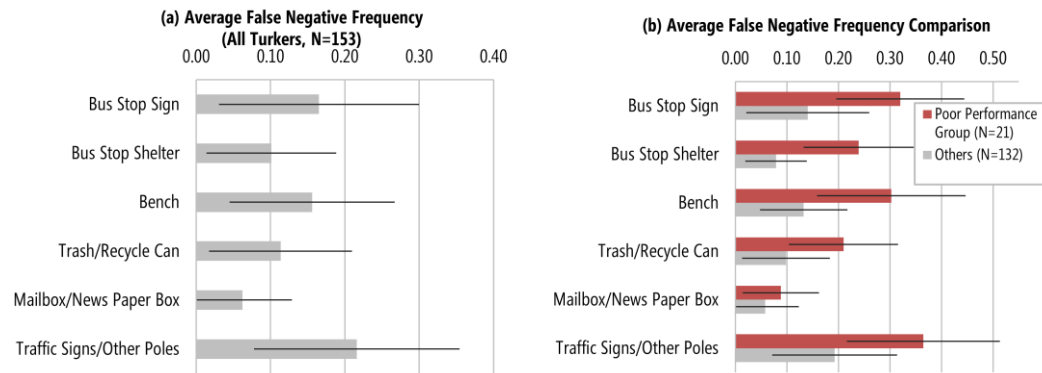
Figure 9: (a) The average number of false negative errors broken down per landmark type. (b) Comparison of average number of false negative errors between poor performance group and others. Error bars indicate standard deviation.

Performance can be further broken down by landmark type (Figure 9). Traffic signs and other poles were missed most frequently, probably because they are the

most open-ended landmark type and confusing label to use (as noted in the overall results). Mailboxes and newspaper boxes had the lowest false negative scores, most likely because they did not appear in many bus stops that were used in our study, and, even when they appeared, they were easy to spot due to their visual salience. These trends occurred for turkers in the poor performance group and in the other group.

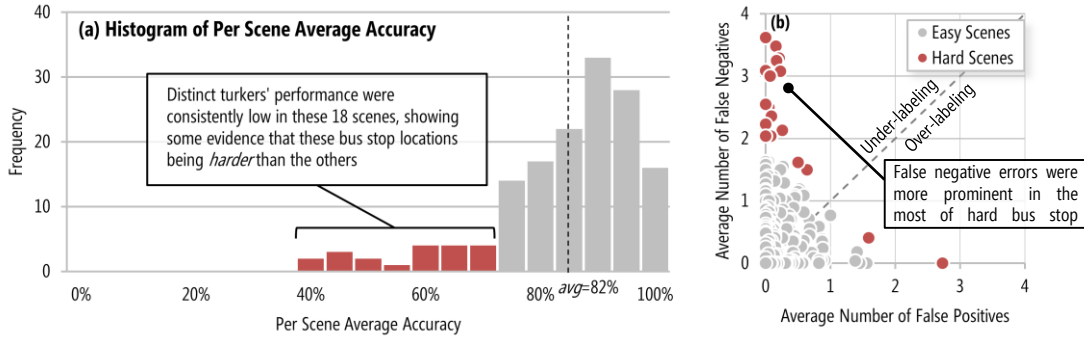
Figure 10: (a) A histogram of per scene average accuracies of 150 bus stop locations. A bin size is 5%, e.g., the bar above “80%” indicates the frequency of bus stop locations with accuracy between 75% and 80%. 18 scenes’ accuracies fell below 69% (one standard deviation away from the mean). (b) A scatter plot that shows the types of errors made in 150 bus stop locations. Each point indicates a bus stop location. Data points for the 18 “hardest” scenes are colored red. The x and y-axis indicates the average number of false positive and false negative errors respectively.

We found that per scene average accuracy varied from 39% to 100% ($Avg=82\%$, $SD=13\%$) across 150 bus stop scenes. Of all the scenes, the accuracy of 18 scenes fell under one standard deviation below the mean ($<69\%$), indicating that distinct turkers consistently failed to provide accurate information about presence/absence of landmarks in these scenes (Figure 10a). Notably, false negative errors (*i.e.*, failing to label existing landmarks) exceeded false positive errors at most of these bus stops (Figure 10b). This suggests that the dominant cause of the low per scene average accuracies is because turkers are under-labeling landmarks.

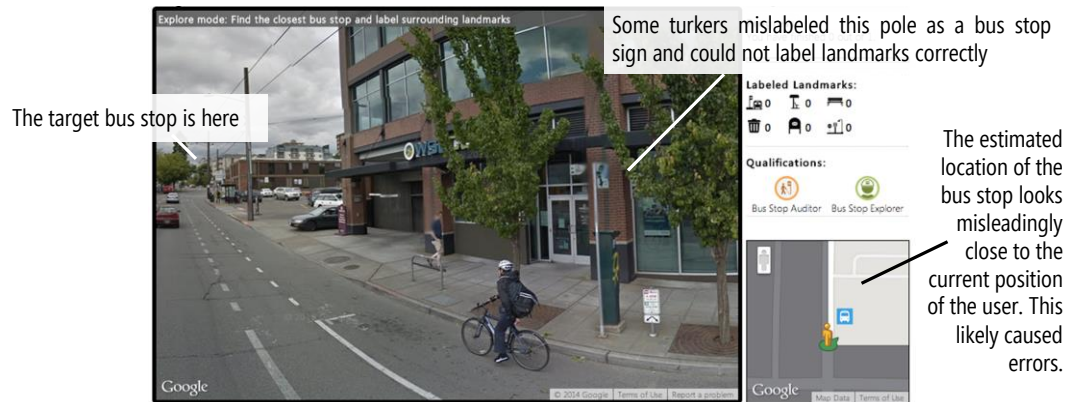
Figure 12: An inaccurate estimated location of the bus stop in the Google Maps pane could confuse turkers. In this picture, the actual bus stop is further down the street, but the bus stop icon on the Google Maps shows that the bus stop should be visible from the current position.

Similarly, often times we found that the exact location of bus stops in the Google Maps API was inaccurate (*e.g.*, wrong place on the block, wrong side of an intersection). This made our 2D-map pane confusing for some scenes—a worker would point the avatar toward the bus stop icon but would not see a bus stop in the GSV pane. We believe this led turkers to label artifacts that are not parts of bus stops or decide to skip and falsely report missing bus stops. This consequently increased false positive and false negative errors. Other data sources (*e.g.*, OpenStreetMap) could likely be used to mitigate this problem. Other task assignment strategies should also be investigated. As current interface drops all turkers at a same place facing a same direction in GSV, many of them might have made same mistakes (*e.g.*, incorrectly skipped a task). We would like to investigate the effect of dropping turkers at slightly different locations, which allows them to observe a same bus stop from various positions and camera angle with different occlusion/lighting conditions.
